# Papworth Everard Conservation Area Appraisal and Management Plan

**23 August 2022**

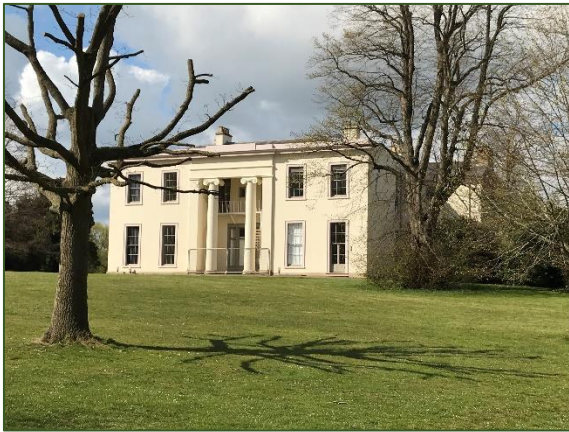
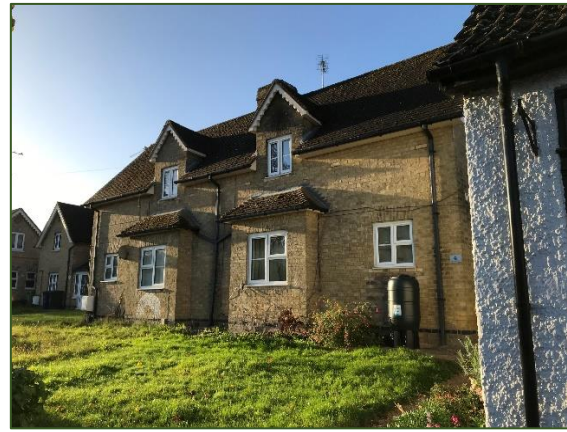
*Above left:* Papworth Hall, seen from the north-east.

*Above right:* 'Model' estate workers cottages, Ermine Street South

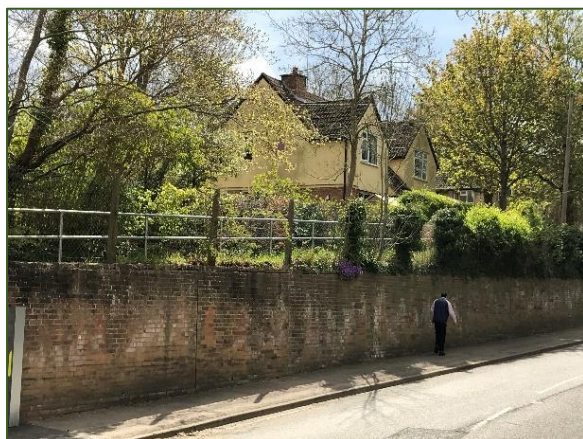
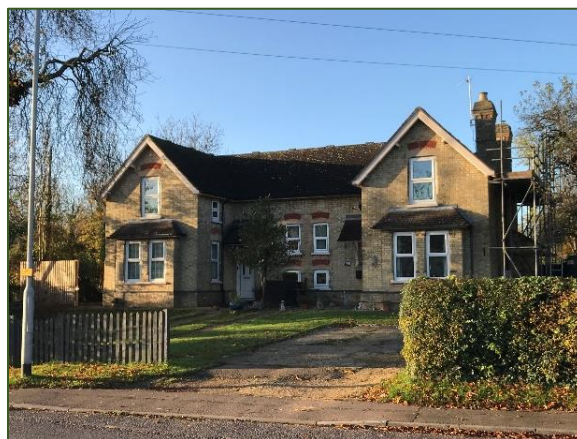
*Below left:* Semi-detached houses behind hedges on Ermine Street South

*Below right:* Typical H-plan semi-detached houses on Ermine Street North

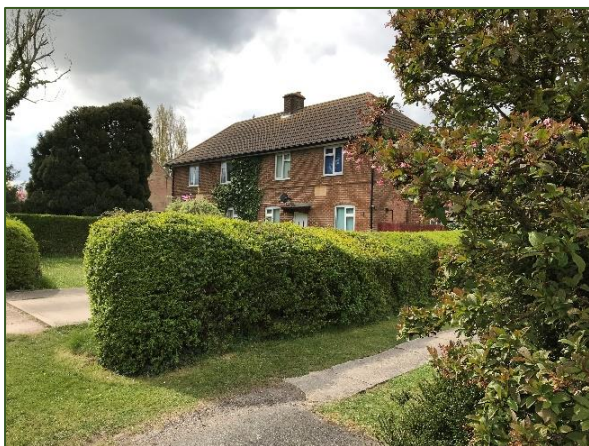
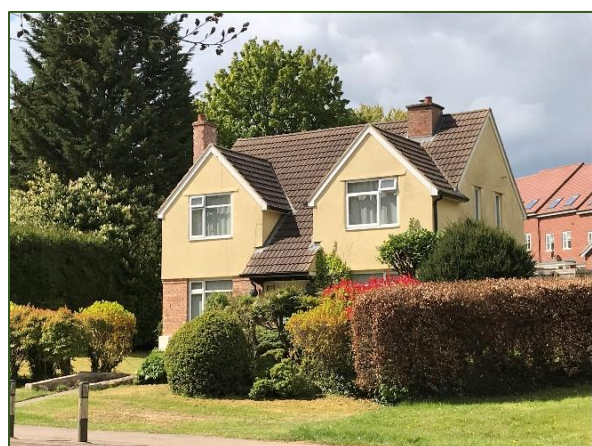
*Left above:* red brick semi-detached houses. *Right above:* render above common bricks. Both buildings on the west side of Ermine Street South

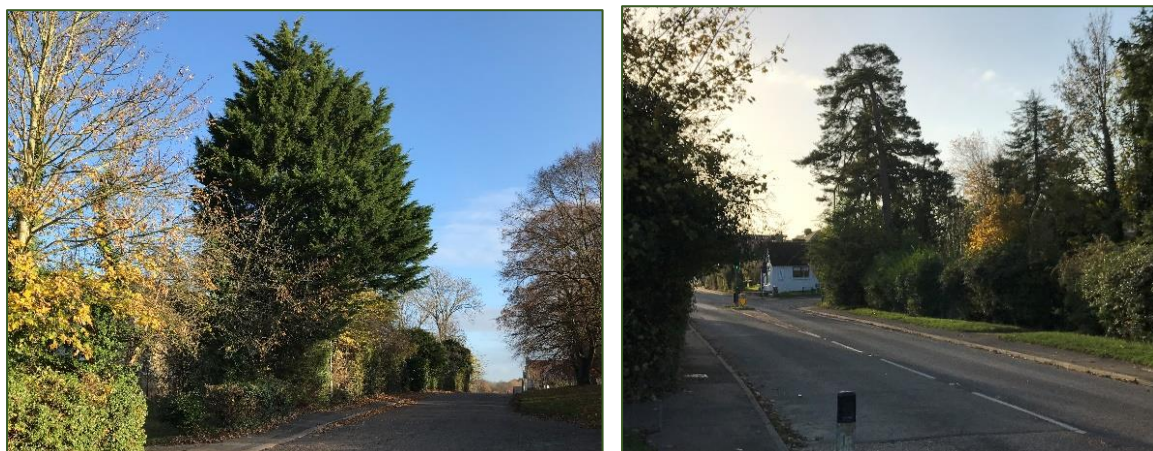
*Below left:* Trees and hedges in Church Lane

*Below right:* Trees and hedges on Ermine Street North

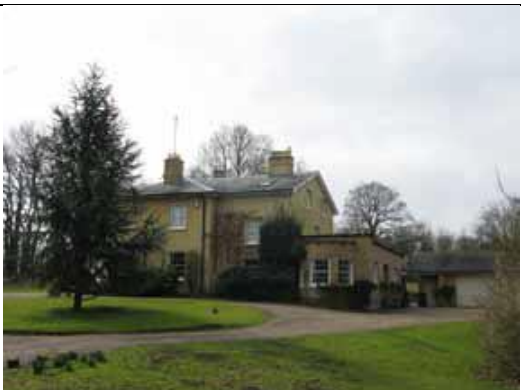
| Building proposed as non-designated heritage asset | Photograph | Explanation of significance |
|---|---|---|
| The Old Rectory | | Built as the New Rectory towards the end of the nineteenth century. Typical Victorian manse with high ceilings and large sash windows. Hipped roof with overhanging eaves supported on decorative brackets. |

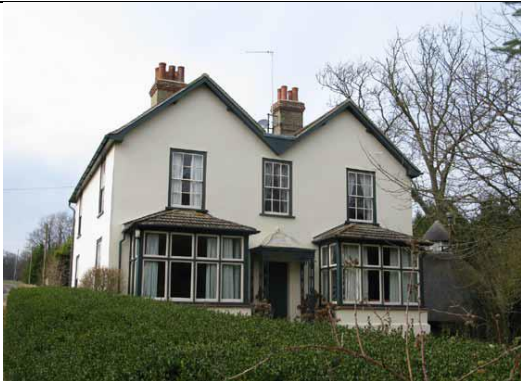
| Building proposed as non-designated heritage asset | Photograph | Explanation of significance |
|---|---|---|
| Fir Tree Farm | | One of the very few pre-19 <sup>th</sup> century buildings in the village. Appears to have originated as an 18 <sup>th</sup> century double-pile farmhouse. |

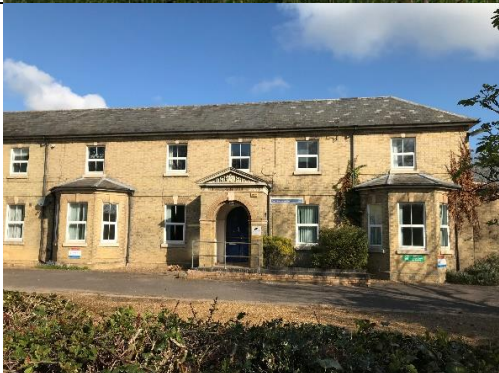
| Building proposed as non-designated heritage asset | Photograph | Explanation of significance |
|---|---|---|
| St Peter's House | | Built in 1860 for organist S.H. Williams Original symmetry of façade lost in later extensions. Inscribed pediment over central entrance. |

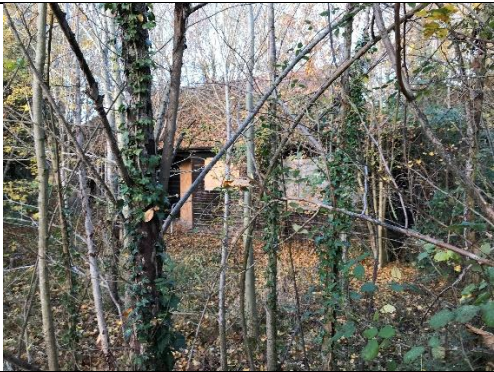
| Fairwood | | One of the last remaining timber construction bungalows of the Village Settlement era. Possibly built by recovering patients. Not radically altered. |

| Fairwood | This building is one of the few remaining timber buildings from the early years of the Settlement, and is a pointer to the architectural history of that era. It has been disused for a lengthy period, and is badly deteriorated. The site is overgrown, and it is clearly a focus for anti-social behaviour. | Options for the future use of this site, and if possible, the retention and conversion of the building need to be explored urgently. There is a case for the retention of this building; if that case is outweighed by benefits from its removal, proper recording of the building should take place. |

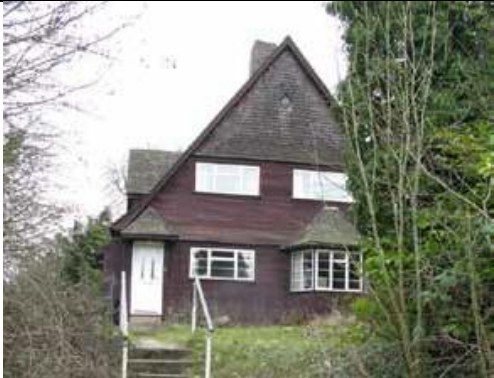
| Cedar House | | 1930's experimental house of unusual design, clad in cedar boarding similar to the huts and bungalows of the Village Settlement at the time. |

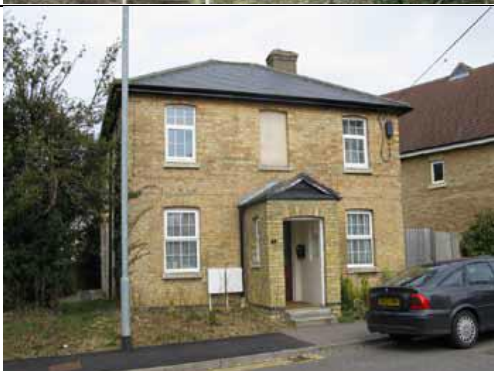
| Former service entrance lodge (1a/1b and 2 North Lodge Drive) | | Original service entrance lodge to Papworth Hall. Although much altered, it illustrates the less decorative design and more rustic materials typical of such buildings. |

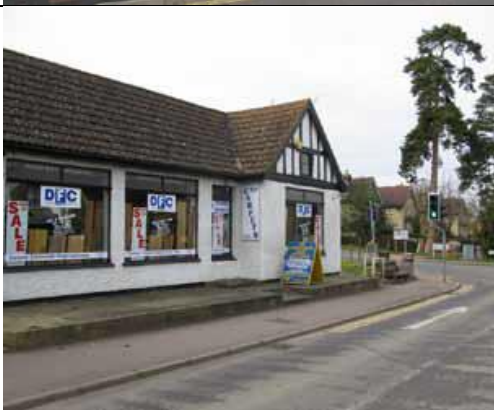
| Former Papworth Stores | | Probably built between 1900 and 1918, and may originally have been a blacksmiths. The cottage vernacular style, with exposed timber framing, suggests late nineteenth century and Edwardian estate and model villages. |

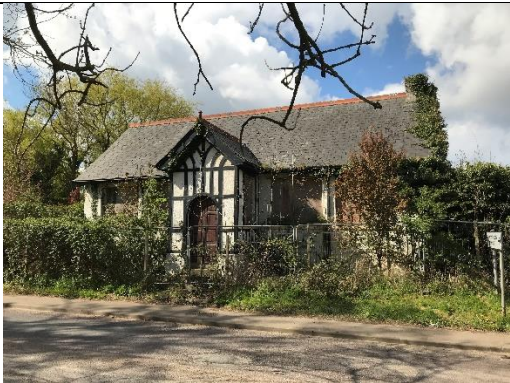
| Estate office | | Probably built between 1900 and 1918. Cottage vernacular style, like the Stores. Served as the Village Settlement / Papworth Trust head office for many years. |

| The former Estate Office | The building, which has had an important role in the history of the village, has been disused for some time, and is deteriorating. It currently creates an eyesore on Ermine Street in a prominent location. | Opportunities for conversion and reuse of this building, which might include removal of later additions and/or linking with a new building should continue to be explored. Demolition of the original building should continue to be resisted. |

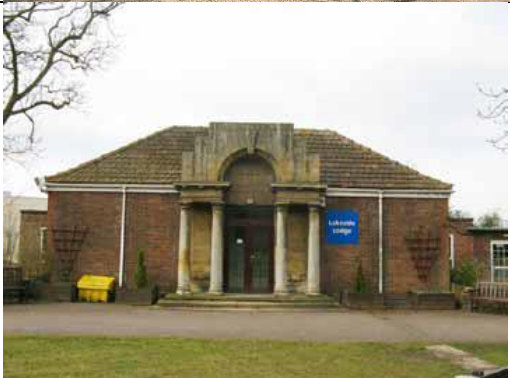
| Simms Woodhead building (Lakeside Lodge) | | Originally the hospital's pathology lab, built in 1926, faced in red brick and clay tiles. The composition and classical entrance appear to be influenced by Lutyens. |

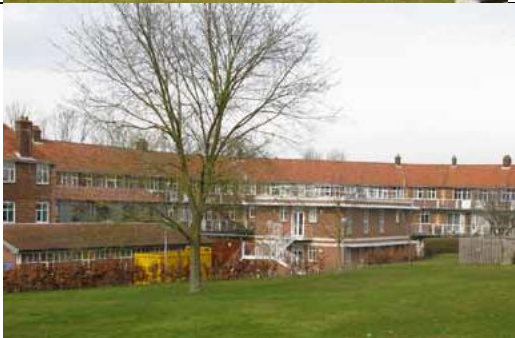
| Bernhard Baron building | | Modernist design with strong horizontal lines. Incorporated new window, door and cladding panel technology. Continuous cantilevered concrete balconies facing south and south-east enabling TB patients to benefit from sunlight, ventilation and fresh air throughout the year. The distinctive curved elevation to Ermine Street in the 'moderne' style is also a prominent landmark |

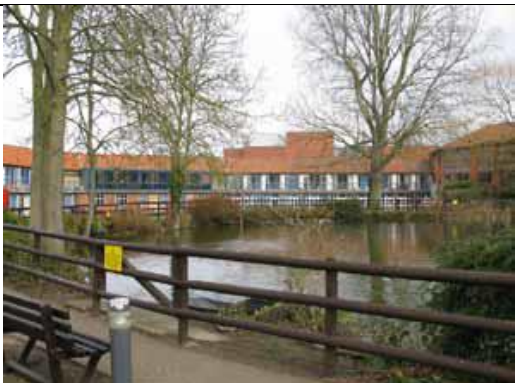
| Princess building | | Similar to Bernhard Baron building, but only two storeys and balconies face SE and SW. |

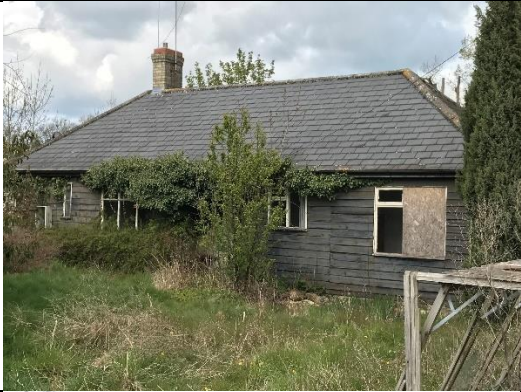
| 1 Farm Road | | One of the last remaining timber construction bungalows of the Village Settlement era. Possibly built by recovering patients. Some alterations. |

| Farm Road and the area south-east of the scheduled monument | Most of the buildings in the Farm Road area have been heavily altered and show few traces of the original character of this part of the conservation area. 1 Farm Road is an exception. It is one of the few examples remaining of the timber construction used in the early years of the Settlement. It has deteriorated through disuse.<br>There are brick walls around the car park area which are redolent of Estate history and contribute visually to the character of this locality. | Options for the future use of the 1 Farm Road site are being explored. There is a strong case for the retention of this building; if it is eventually decided that this is outweighed by benefits from demolition, proper recording of the building should take place.<br><br>Development in this area should retain the positive brick walls. |

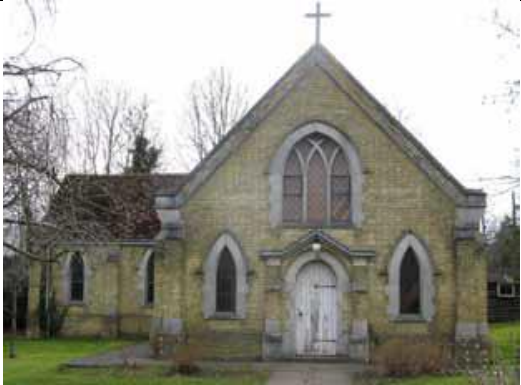
| St Thomas Indian Orthodox Church (former Methodist chapel) | | Built in 1926 in local yellow bricks with kneelers, parapets and reveals in white gritstone. Fibre tile roof. Details with high water exposure (parapet copings, sills) in concrete, coloured and cast to imitate stone. |

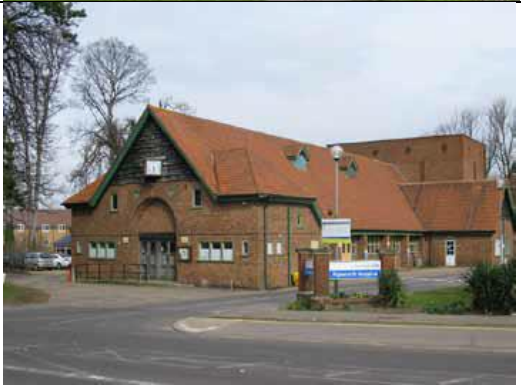
| Village Hall | | Built 1928. Of singular design with allusions to arts and crafts style. Machine-made bricks and clay tiles. Incorporates robust large section joinery, probably made in the village workshops. |

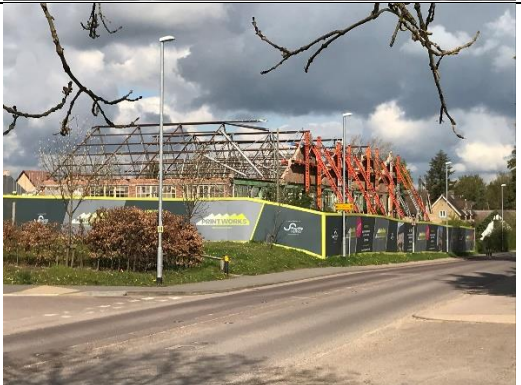
| Former printing works | | Built 1929, foundation stone laid by H.R.H. Duke of York, later George VI. The factory was initially used for cabinet making, and then printing. Extended 1939. The south, north and east elevations and roof trusses are the only surviving elements of the workshops where recovering patients were employed, a key element of the 'Papworth system' |
