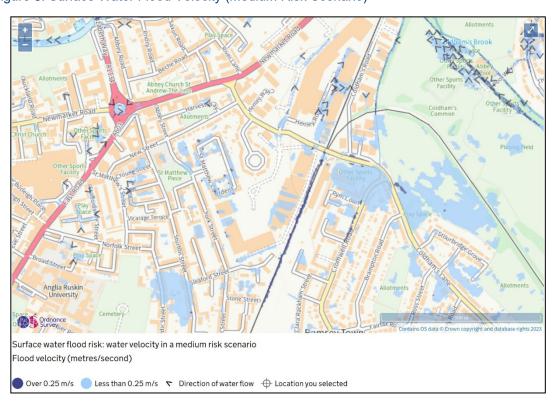
Figure 7: Surface Water Flood Depth (Medium Risk Scenario)

Figure 8: Surface Water Flood Velocity (Medium Risk Scenario)

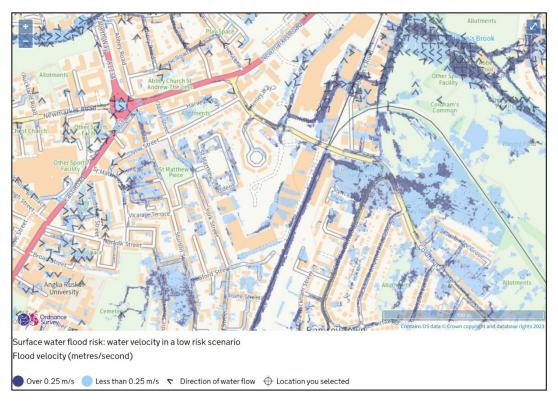
Figure 9: Surface Water Flood Depth (Low Risk Scenario)

Figure 10: Surface Water Flood Velocity (Low Risk Scenario)

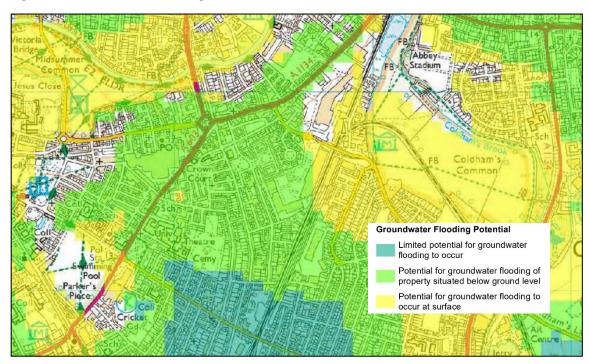
Figure 11: Groundwater Flooding Potential

4.14. Based upon Appendix D10 of the Level 1 SFRA the majority of the Site is shown to be at low potential for groundwater flooding. The majority of the Site is designated as having 'Potential for groundwater flooding of property situated below ground level' which is typical of an area with a relatively shallow groundwater table. Refer to extract in Figure 11.
