1.0 INTRODUCTION

1.1 The Oakington Conservation Area was designated on 28 August 1989. This document aims to fulfill South Cambridgeshire District Council's duty to 'draw up and publish proposals for the preservation and enhancement' of these areas as required by the Planning (Listed Buildings and Conservation Areas) Act 1990 and the commitment made by policy EN29 in the adopted Local Plan. This document includes; a character appraisal, design guidance for new development, and policies for the management of the area in order to preserve its character.

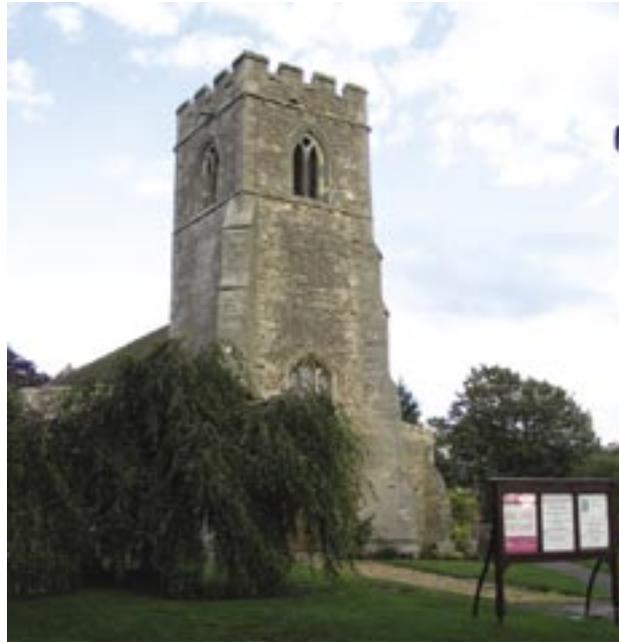
St Andrew's Church

7.1 The main historic building in the village is the C13 Church of St Andrew (map: I). At the west end of this Grade II* Listed Building is a four-stage tower with battlements that is prominent in several views within the village. The church is of various limestones, pebble- and pudding-stones and has a clay tiled roof.

7.2 The church has a pleasant setting in the middle of a substantial green. The roadside verge is lined with trees and visible between them are various sporadically placed graves. The church sits at 45 degrees to the road here and the north aisle with its C15 doorway is particularly visible. Adjacent to the road are some plastic bollards leaning at various angles. These bollards would be

best removed or replaced with ones of a more appropriate design and material. Similarly the streetlight which marks the end of the path to the church is rather utilitarian in appearance and could be improved upon.

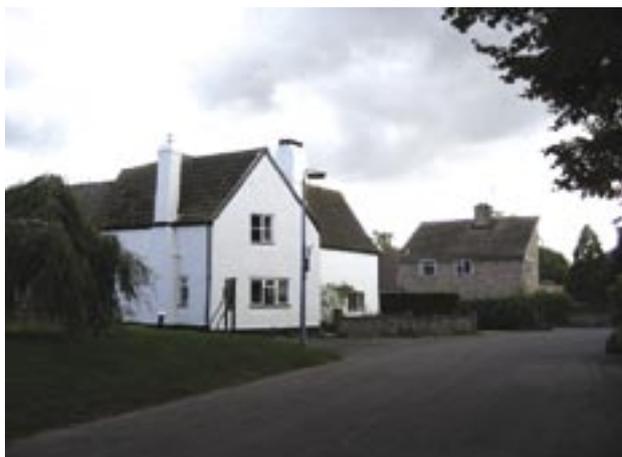
7.4 To the west of the church is No. 68 High Street (map:2). This property (which is Grade II Listed) dates back to the C16 and originally comprised a hall with crosswing. The large chimney stack between the two elements of the building is particularly prominent. The property is built of timber frame and rendered, painted white. The building would be significantly enhanced if the concrete roof tiled and modern windows were replaced by more sympathetic components of traditional form. The concrete boundary wall to the road is similarly out of keeping with the historic origins of the site.

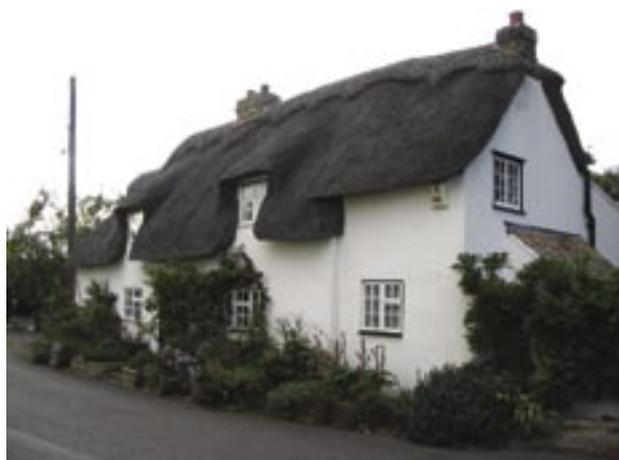
7.6 Immediately south of the driveway to Manor Farm is No. 69 High Street (map:3), an attractive one-and-a-half storey early C18 cottage with eyebrow dormers, that is a Grade II Listed Building. The cottage is thatched and mostly timber framed covered with white painted render. The majority of the windows are modern. This cottage and No. 68 opposite are an attractive pair at a key area within the village.

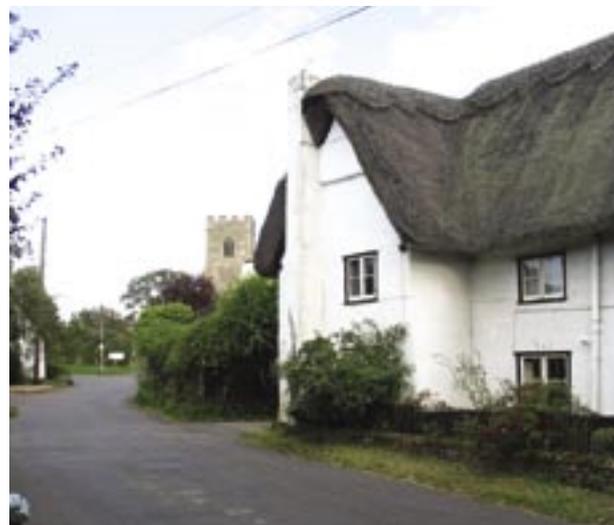
No. 56 High Street

7.7 Further down the High Street, on the south side, is No. 56 which is also known as Church Farmhouse and is a Grade II Listed Building (map:4). It dates back to the C15 and had a similar hall and crosswing plan to No. 68. The house is of two full storeys and has simple casement windows and a prominent chimney stack on the gable facing the road. It is one of a group of historic Listed Buildings within the core of the village. The C19 brick and slate property opposite helps produce a pinch-point in the street which emphasises the importance of the historic properties to the character of the village (map:C).

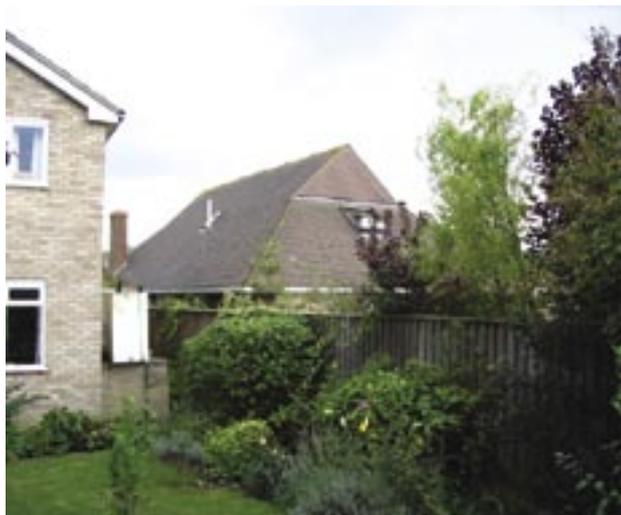
Modern houses on the High Street

7.8 Infilling between this group of historic buildings are a series of late C20 houses set back from the road. None of these have the character of the traditional buildings in the village, though the gambrel roof of No. 64 is an unusual feature on a modern dwelling. The unsympathetic concrete boundary wall to No. 68 continues in front of No. 66 (suggesting that this dwelling was built within the garden of No. 68). Behind this property is a low key commercial building, which nonetheless is out of keeping with the historic core of the village.

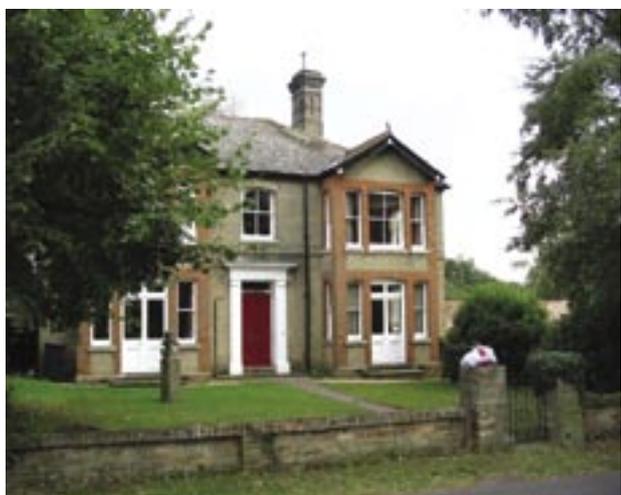
No.54 High Street

7.9 No. 54 (map:D), located to the south of No. 56, is a very fine C19 house set back from the road beyond a lawn containing a pair of mature trees and with a low brick boundary wall to the street. The house is built of gault brick with red brick detailing under a Welsh slate roof. Two bays face the road, each containing French windows, and between the bays is a simple Classical doorcase. The windows are plate glass sashes.

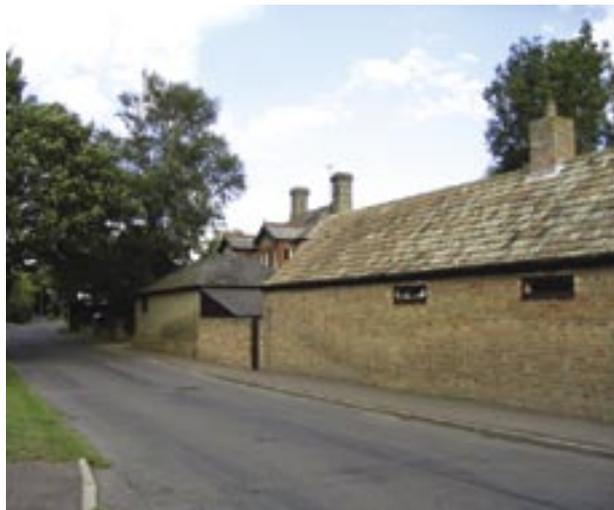
7.10 Beside this substantial house is a series of single storey outbuildings of gault and pink brick known as Maris Barn (map:E). The smallest, nearest the house has a hipped slate roof, whilst the larger range which lines the footpath edge has triple-roll pantiles. These converted buildings neatly define the street and form a pleasant group with the main house and trees.

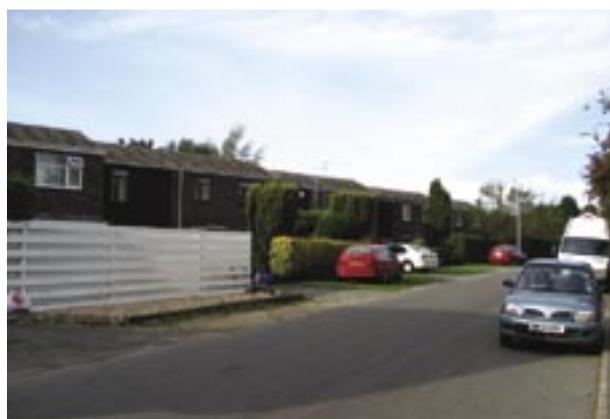
No. 35 High Street

7.11 At this point there is virtually an archway of trees over the road and the rural feel of the village is consolidated by the grass verge on the north side of the street, though most of the housing in this area is again late C20 and lacks the character of the traditional properties. Most of the dwellings on Manor Farm Close lie outside the boundaries of the Conservation Area, but the stepped group of 1970s houses on the south side of Manor Farm Close are within and have a strong suburban feel. The grass verge in front of these houses is potentially an attractive feature, but is mostly lost to car parking, whilst the high white painted timber fence to No. 35 is very intrusive. The impact of this fence could be moderated through planting, and would be further improved if stained or painted a darker colour.

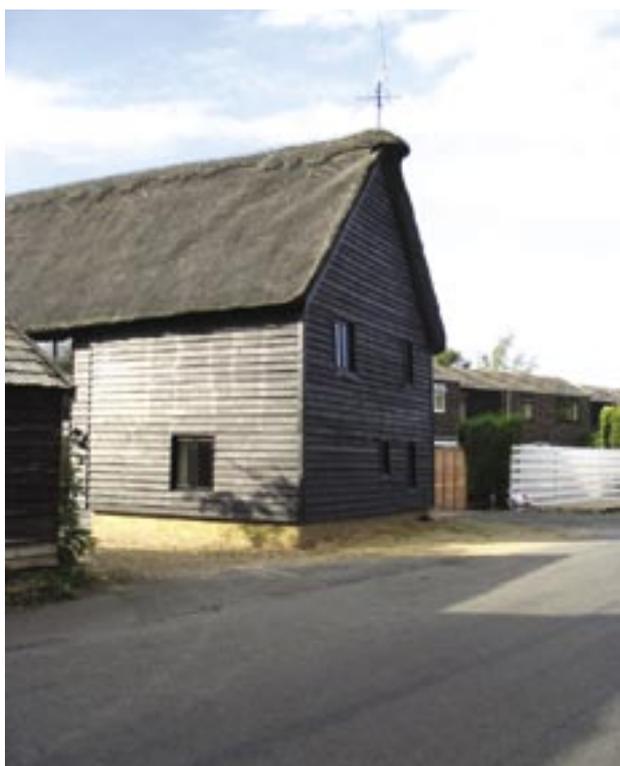
Converted barn, High Street

7.13 On the opposite side of the road is a weatherboarded barn with a thatched roof which has been converted to a house (map:F). This stands gable end to the road and complements the agricultural feel of this part of the village. A smaller outbuilding, also weatherboarded but with a pantiled roof lines the road with a C19 house of painted brick and slate beyond.

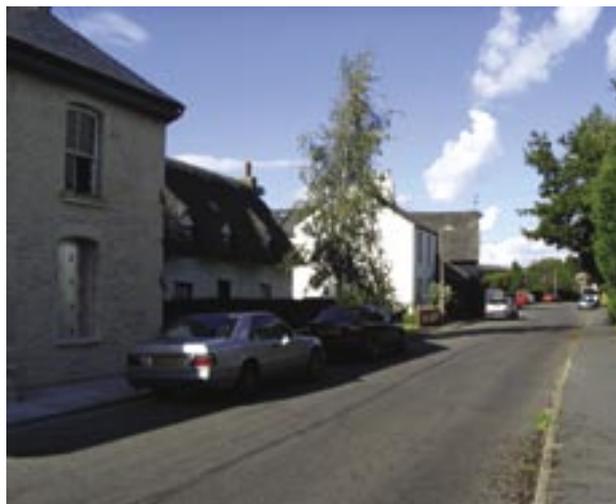
Nos. 25 & 27 High Street

7.14 Nos. 25 and 27 are a pair of C17 / C18 cottages with rendered walls under a thatched roof with four gabled dormers (map:5). The cottages are Grade II Listed and are set back from the road behind a hedge. On the corner of Coles Lane is a pleasant C19 house that once incorporated a bakery and shop (map:G). The building is of two storeys with gault brick walls under a slate roof and was modernised in 2004 when much of the single storey corner and adjacent gable end were rebuilt. The windows are 2 over 2 plate glass sashes.

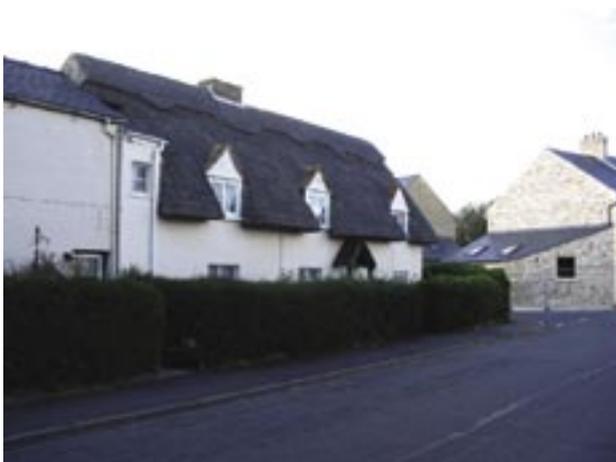
7.15 On the opposite corner of Coles Lane is No. 19 High Street (map:H), a thatched property of similar age and character to Nos. 25 and 27 High Street (though not listed). This dwelling has walls of white painted render under a thatch roof that incorporates three gabled dormers with clay-tiled roofs. Adjoining this is a C19 wing with similar painted rendered walls and a Welsh slate roof. The building sits behind a hedge that turns the corner from High Street into Coles Lane.

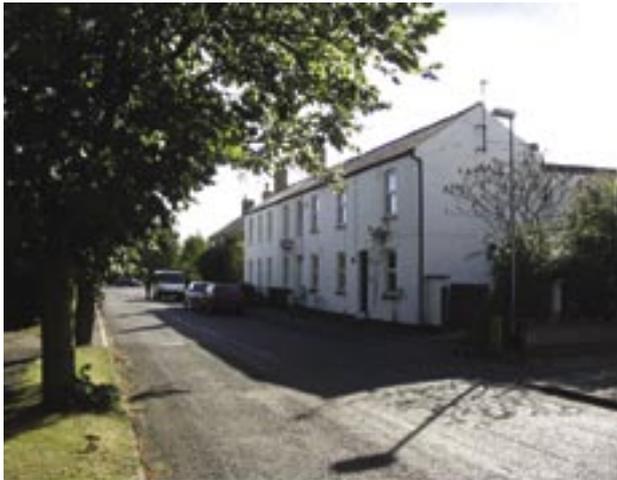
Nos. 9-13 High Street

7.16 Continuing down to the junction with Water Lane are a row of C19 houses (Nos. 9-13 High Street) with painted brick walls and Welsh slate roofs (map:I). This is a pleasant two-storey terrace sited on the back edge of the pavement, though the loss of the original sash windows and chimneys has diminished its character. Beyond the terrace, the penultimate house within the Conservation Area is No. 5 which is again C19 and of gault brick with a slate roof (map:J).

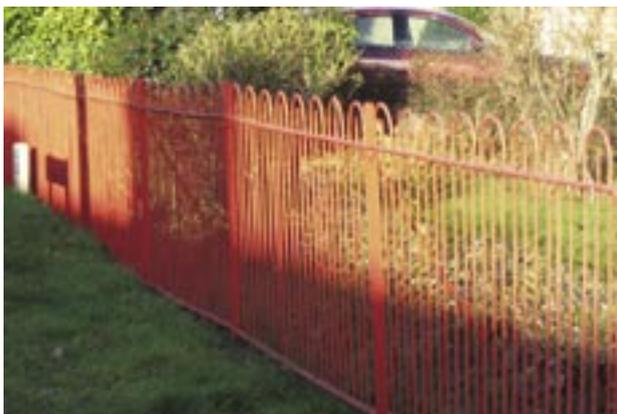
Hooped railings at No. 14 High Street

7.18 No. 14 has a boundary formed of the original hooped railings of the chapel. These are an attractive survival. No. 12, the property on the northern corner of the chapel lane, has a monopitch roof with blue boarding. Next to this house is an attractive triangular grassed area with mature trees that leads down a short pedestrian lane to the Baptist Chapel.

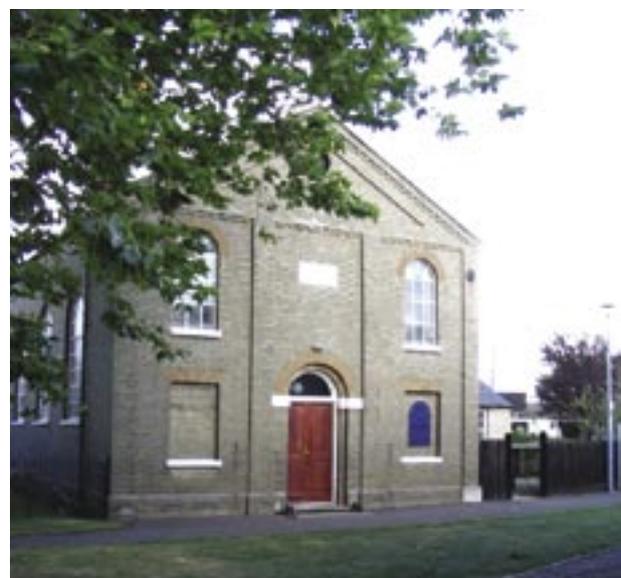
7.19 Oakington was once a hot-bed for religious dissent and this has resulted in a substantial and imposing Baptist Chapel (map:K). The present chapel dates from 1865, when it was re-built following a fire. It stands gable end onto the lane and is built of gault brick under a Welsh slate roof. Although quite plain, the front elevation has a restrained dignity with a simple pediment supported on brick pilasters, arched headed windows to the first floor and blind windows with flat brick arches of rubbed bricks on the ground floor. An adjoining single storey building to the southeast was originally the schoolroom and is dated 1877. This is also of gault brick with a slate roof and has 6 over 6 sash windows. The simple gabled porch has the names of the trustees carved into the brickwork. The original hoped-topped railings survive on the northwest side of the chapel, but to the southeast they have been replaced by a modern timber fence, with only the original gate remaining.

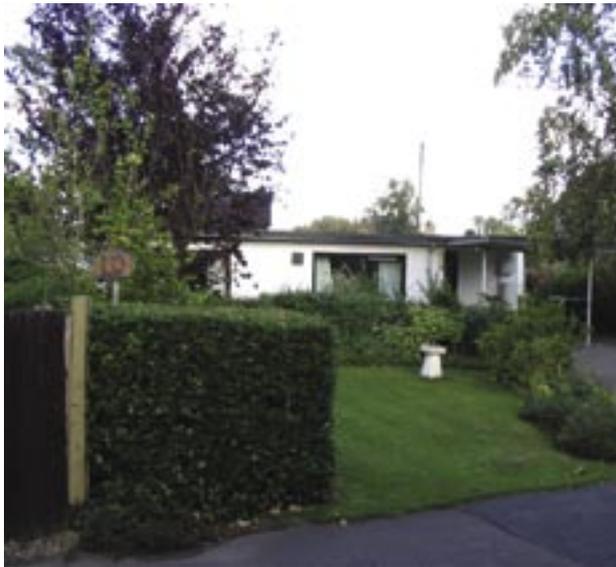
No. 10 High Street

7.20 Tucked in between the church and the Water Lane properties is a modest single storey flat roofed house (No. 10 High Street) which dates from the 1960s. Although the building is of a contrasting form to the traditional buildings in the village, it is a modest and unassuming contemporary structure with white-painted walls and a well-maintained garden.

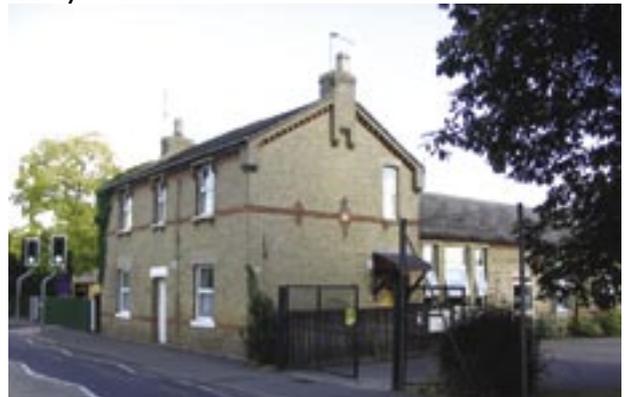
School House

7.23 The School House, which is located on the southeast side of Water Lane, is outside the boundaries of the current Conservation Area, but is a substantial property that complements the setting of the Conservation Area (map:M). It is built of gault clay brickwork with red brick detailing under a Welsh slate roof and was built in 1871. Unfortunately it no longer retains its original sash windows, but it remains a building of some character. To the rear are more modern single storey extensions.

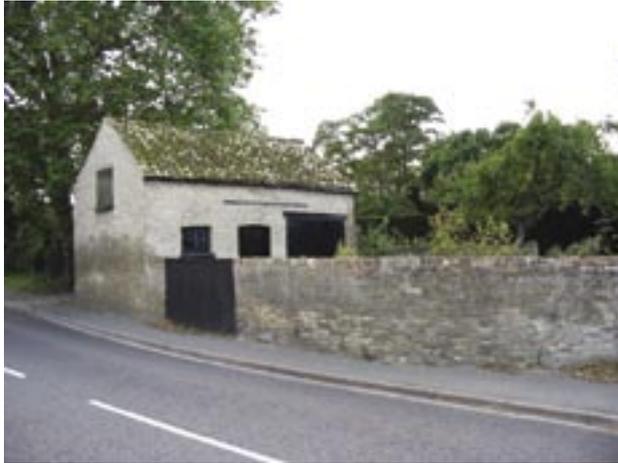
Coach house to the vicarage

7.28 The trees are complemented by the strong hedge in front of the vicarage, where a gap in the trees allows a glimpse of this C19 gault brick building with its Welsh slate roof and sash windows (map:N). The beautifully maintained box hedges in the garden to the vicarage provide a pleasant contrast with the more natural hawthorn hedges elsewhere in the village. Beyond the entrance to the vicarage is a small coach house of brick and slate with a brick wall turning the corner and defining the lane to the church (map:O).
