## **Appendix 1**

Baseline data of risk of deterioration to water bodies from water abstraction – updated November 2023

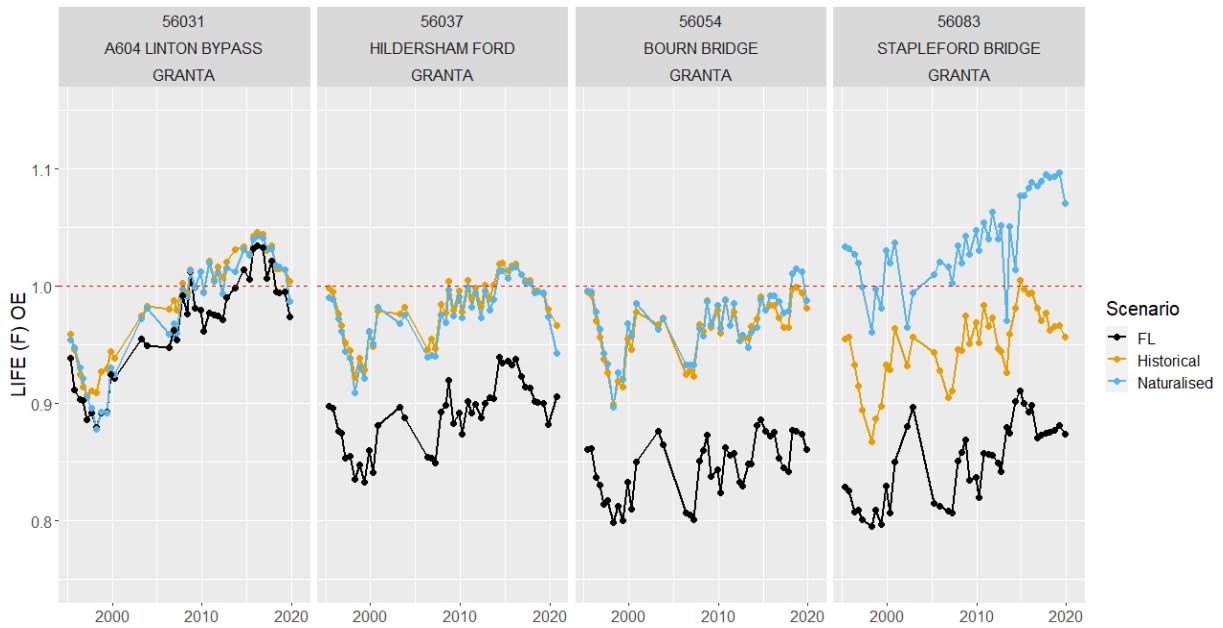
Figure 1 - Predicted LIFE (F) O/E scores for historical, naturalised, and fully licensed scenarios for four sites in GB105033037810 Granta

- 3.1.8 The hydroecological model outputs did not indicate an abstraction pressure impact at Q75 on the macroinvertebrate community at the two most upstream sites, A604 Linton Bypass (56031) and Hildersham Ford (56037), with historical and naturalised scores for both O/E metrics displaying similar values. In contrast, an increasing abstraction impact is observed moving downstream to sites Bourn Bridge (56054) and Stapleford Road Bridge (56083) (see Figures 1 and 2).

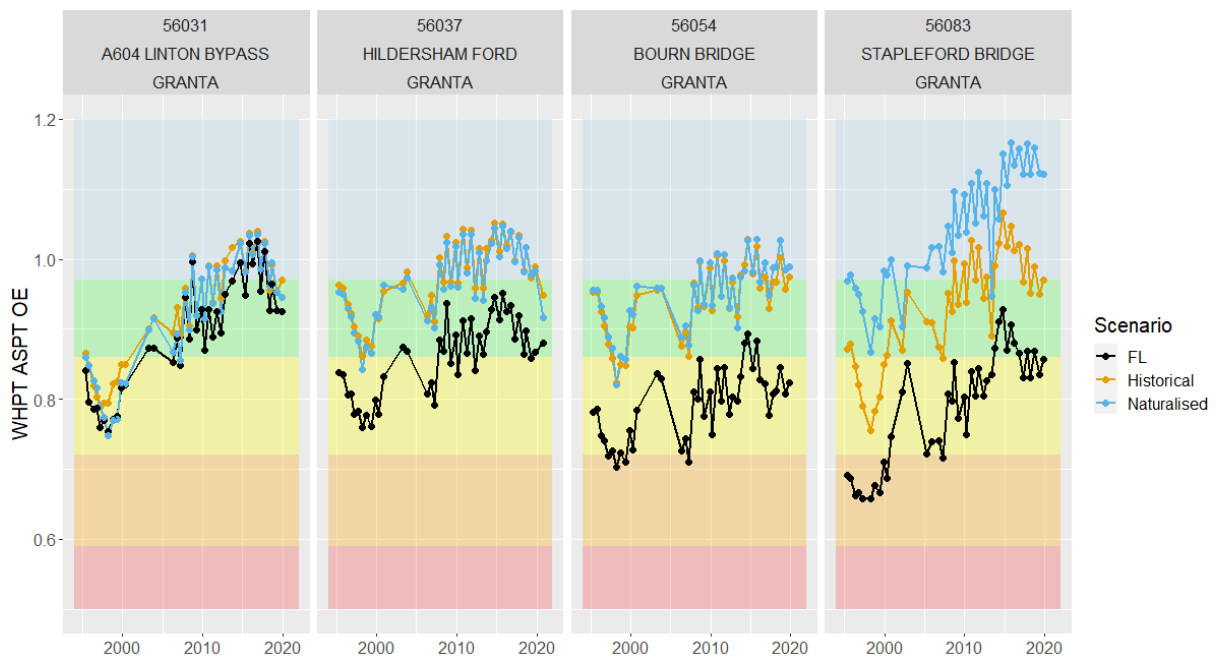
Figure 2 - Predicted WHPT-ASPT O/E scores for historical, naturalised, and fully licensed scenarios for four sites in GB105033037810 Granta

sites, WHPT-ASPT O/E scores do show instances of indicative macroinvertebrate WFD class deterioration from High-Good status.

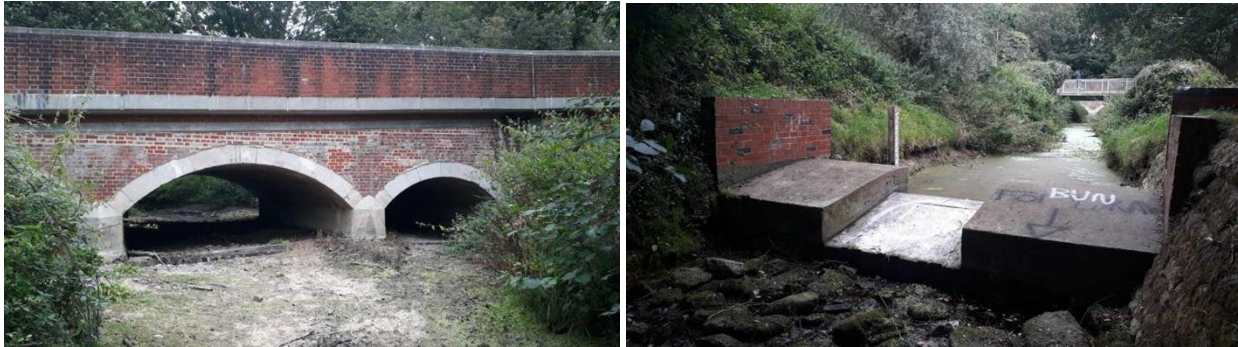
Figure 3 - Images showing dry riverbed at Stapleford gauging weir on the river Granta during prolonged dry weather in 2019

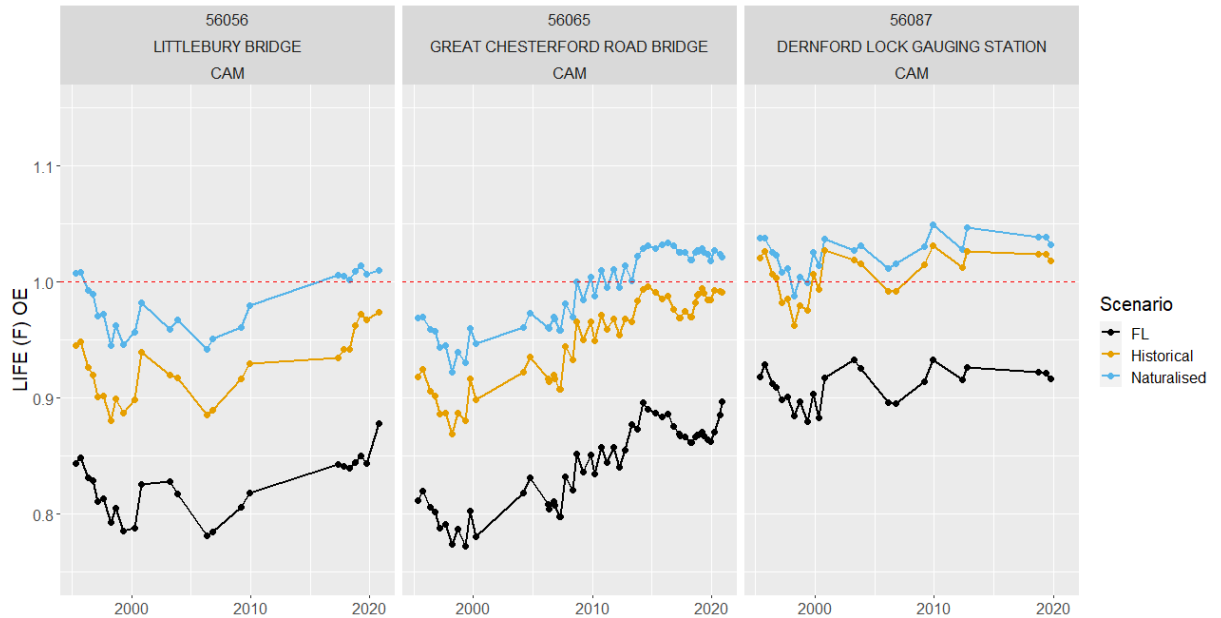
Figure 4 - Predicted LIFE (F) O/E scores for historical, naturalised, and fully licensed scenarios for sites in GB105033037590 Cam (Audley End to Stapleford)

Chesterford Road Bridge (56065) shows instances of a two-class deterioration from High to Moderate, and of a one class deterioration from either Good to Moderate or High to Good status. Similarly, Dernford Lock Gauging Station (56087) shows instances of deterioration from High to Good status.

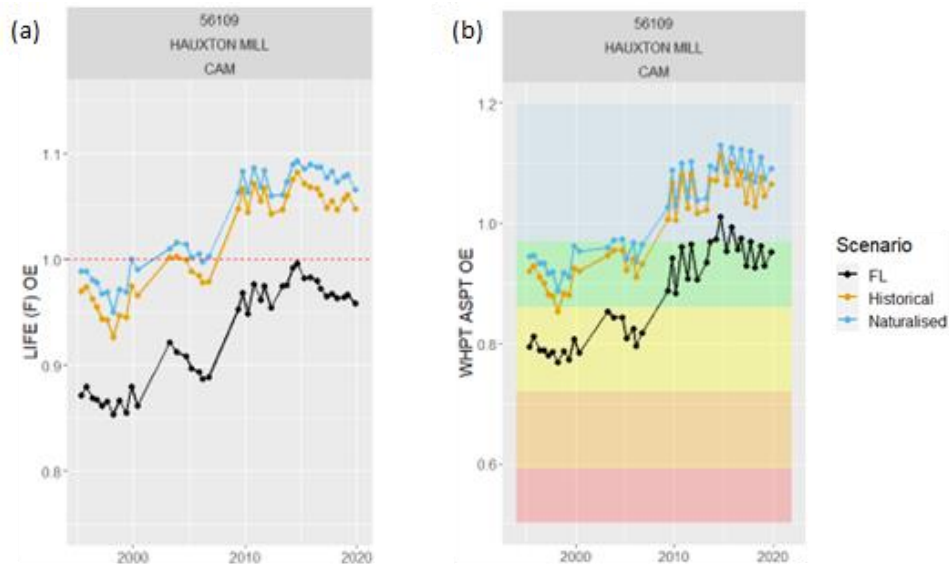
Figure 6 - Predicted LIFE (F) O/E and WHPT-ASPT O/E scores for historical, naturalised, and fully licensed scenarios for Hauxton Mill, River Cam in GB105033037600 Cam (Stapleford to Hauxton Jct.)

- 3.3.3 The model output indicated an abstraction pressure impact on the macroinvertebrate community within the waterbody. Predicted historical LIFE (F) and WHPT-ASPT O/E scores are lower than predicted naturalised scores, indicating an impact of abstraction pressure on the macroinvertebrate community throughout the timeseries, which continues into recent years (2015-2020) (see Figure 6).
- 3.3.4 The model output for the Fully Licensed (FL) scenario indicated a significant adverse impact to macroinvertebrate communities due to increased abstraction pressure. Recent (2015-2020) LIFE (F) O/E scores are predicted to significantly decline and fall below the threshold of 1.0 and the indicative macroinvertebrate WFD class status is predicted to decline from High to Good status.

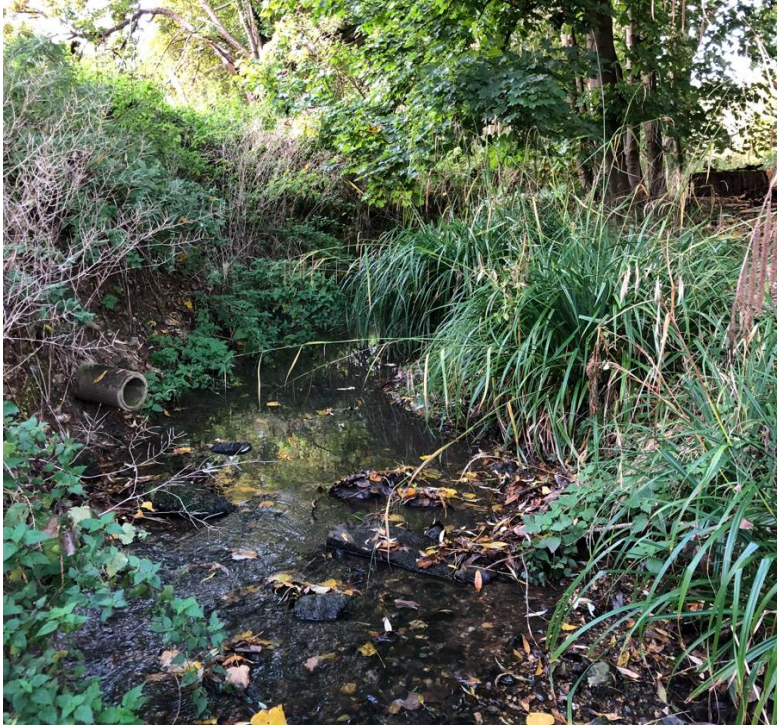
Figure 7 - Macroinvertebrate sample site on Wendon Brook (56055)

- 3.4.4 The macroinvertebrate community at the Wendon Brook site does respond to prevailing flow conditions when assessed via HEV plot, showing declines during periods of low flow but recovers well during higher flows. There is a clear deterioration in the LIFE O/E ratio during prolonged dry weather periods where flow sensitive taxa such as the freshwater shrimp *Gammarus pulex* and the mayfly *Baetis rhodani* decrease in abundance and others such as the caddisfly *Agapetus*

*fuscipes* are lost from the site. This provides evidence of acute flow sensitivity on this waterbody and suggests an increase in abstraction pressure would have a negative impact at this site. Furthermore, the loss of taxa from the site would result in a decline in WHPT-NTAXA which could cause a risk of deterioration under WFD classification.

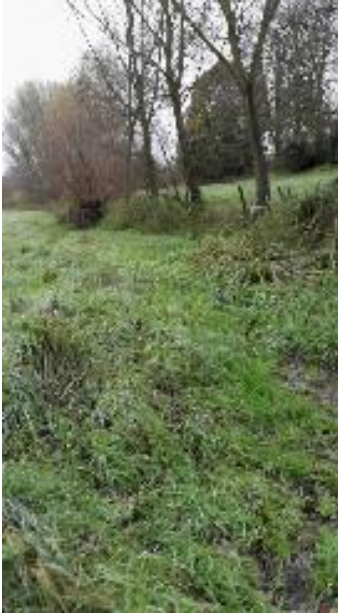
Figure 8 - Macroinvertebrate sample site on Ickleton Brook (161079)

- 3.5.3 Monitoring on this watercourse was established in 2013 as part of the WFD programme. The site was visited Spring and Autumn in 2013 and was found to be dry in October. It was monitored again in 2015 when a classification status of Moderate was assigned and investigated. The investigation identified the hydrological regime as a considerable influence on the ecological community as the site was prone to drying. Periods of low flow were also deemed to be affecting the dissolved oxygen levels, which in turn acted to restrict the macroinvertebrate community which was able to colonise during the wet phases.

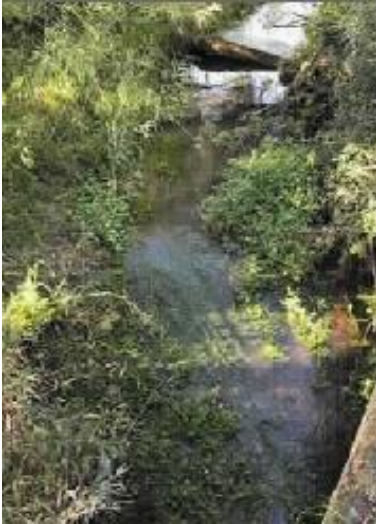
Figure 10 - Macroinvertebrate sample site on Mill River (56160)

3.7.2 HEV plot analysis has shown that the macroinvertebrate community does respond to flow pressure at the sample site however, this has not caused significant deviation to the LIFE O/E ratios or the overall ecological health WHPT-ASPT O/E and WHPT-NTAXA O/E since 2000. The watercourse in the location of the sampling site has undergone significant marginal bank and in-channel enhancement in recent years, including features which have resulted in channel narrowing resulting in improved flow velocities. These enhancements will be influencing the macroinvertebrate community able to colonise the site.

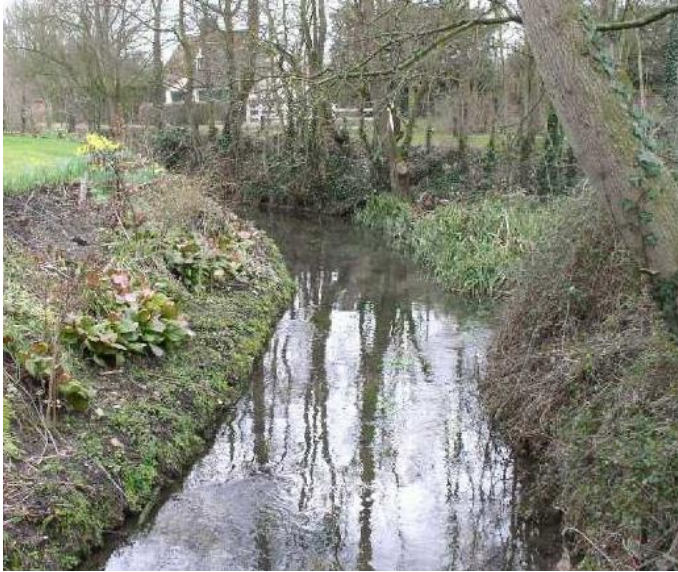
Figure 12 - Macroinvertebrate sample site on River Mel (56139)

- 3.9.3 The macroinvertebrate community at the sample site on the river Mel has routinely been reported at High status under WFD and has therefore not been reviewed in that context.

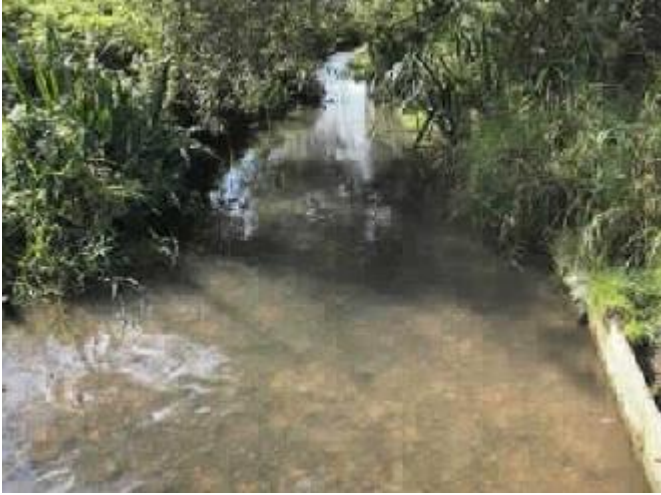
Figure 13 - Macroinvertebrate sample site on River Shep (56128)

3.10.2 The HEV analysis shows that the macroinvertebrate community does respond to flow pressure at the sample site, with long-term data trends indicating impacts during low flow periods. However, a recent impact from signal crayfish activity has been detected which has caused a decline in the WHPT-NTAXA O/E and increases in LIFE O/E and WHPT-ASPT O/E, making it difficult to interpret the recent data.

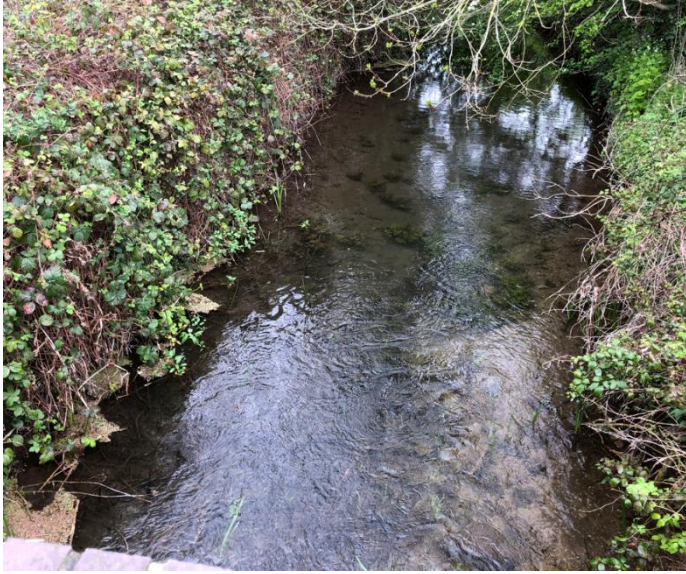
Figure 14 - Macroinvertebrate sample site on Hoffer Brook (56121)

3.11.2 This waterbody had a historical macroinvertebrate site, which was reinstated in 2012 as part of the WFD programme. The HEV analysis indicates that the macroinvertebrate community does respond to flow pressure at the sample site, particularly around low flow periods, based on a limited number of sampling events. Abundances of the freshwater shrimp *Gammarus pulex* and flow sensitive mayfly and caddisfly species (such as *Hydropsyche* sp. and *Sericostoma personatum*) were all lowest in the immediate aftermath of dry weather events. This indicates that the macroinvertebrate community at the site is susceptible to flow pressures. The river support scheme is therefore critical to maintaining the macroinvertebrate community in this waterbody.

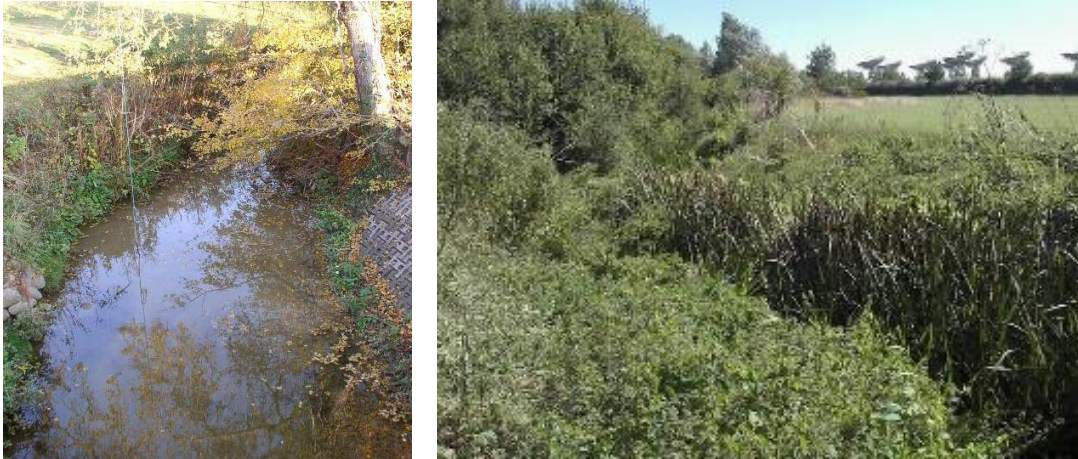
Figure 15 - Macroinvertebrate sample sites on Bourn Brook (56154 and 161112)

4.1.2 The macroinvertebrate communities at the sample sites on the Bourn Brook have routinely been reported at Good status under WFD and have therefore not been reviewed in that context.

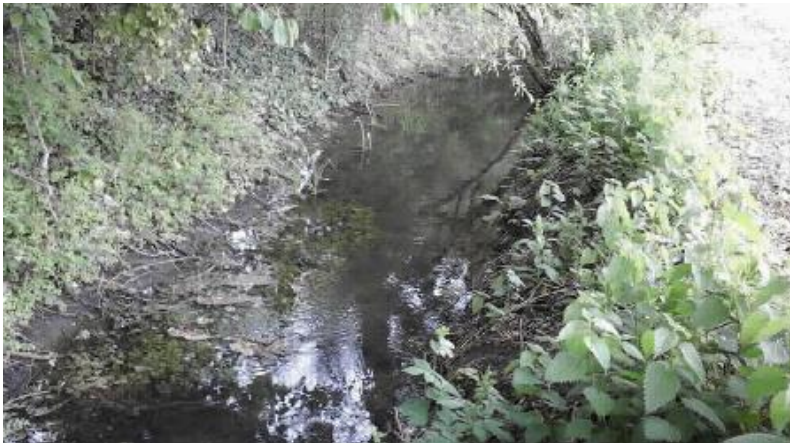
Figure 16 - Macroinvertebrate sample site on Hobson's Brook (186045)

- 4.2.6 In accordance with WFD rules, a monitoring point was established in the lower reaches of the waterbody, but this did not account for the complexities of the watercourse route through Cambridge. As such, a site in the upper reaches of the waterbody was established specifically to monitor the hydrological pressures acting on the macroinvertebrate community, particularly considering the Nine Wells support scheme implemented in mid-2020.

- 4.2.7 Further data will be required to understand the effectiveness of the river support scheme, but initial data indicates that the additional water in the Brook has given rise to increased abundances of some flow-sensitive taxa including the caddisfly *Agapetus fuscipes*, blackfly larvae *Simulium* sp. and the freshwater limpet *Ancylus fluviatilis*. The river support scheme is likely to be critical to the macroinvertebrate community in this waterbody.

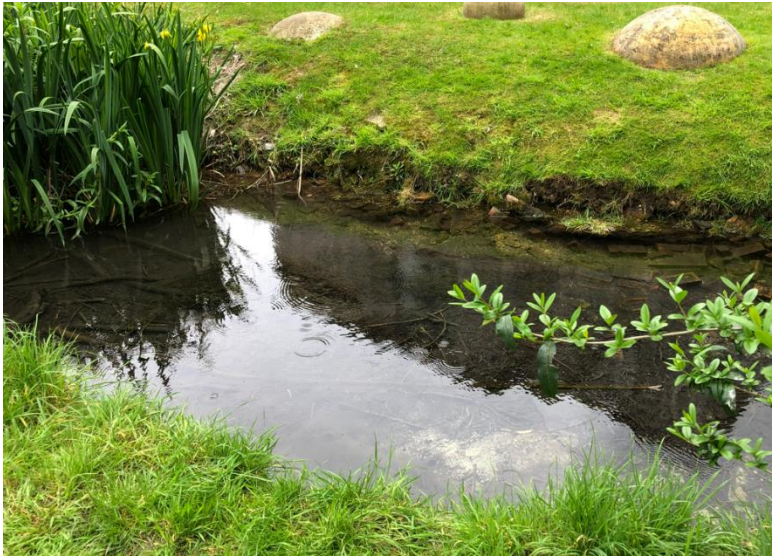
Figure 17 - Macroinvertebrate sample site on Cherry Hinton Brook (196711)

- 4.3.4 In accordance with WFD rules, a monitoring point was established in the lower reaches of the waterbody, but this did not account for the complexities of the interaction with another watercourse, the East Main Drain, through Cambridge. A site in the upper reaches of the waterbody was established specifically to monitor the hydrological pressures acting on the

macroinvertebrate community. The new site was established in 2019 and as such, there is currently insufficient data for analysis to be undertaken to understand potential impacts on the macroinvertebrate community.

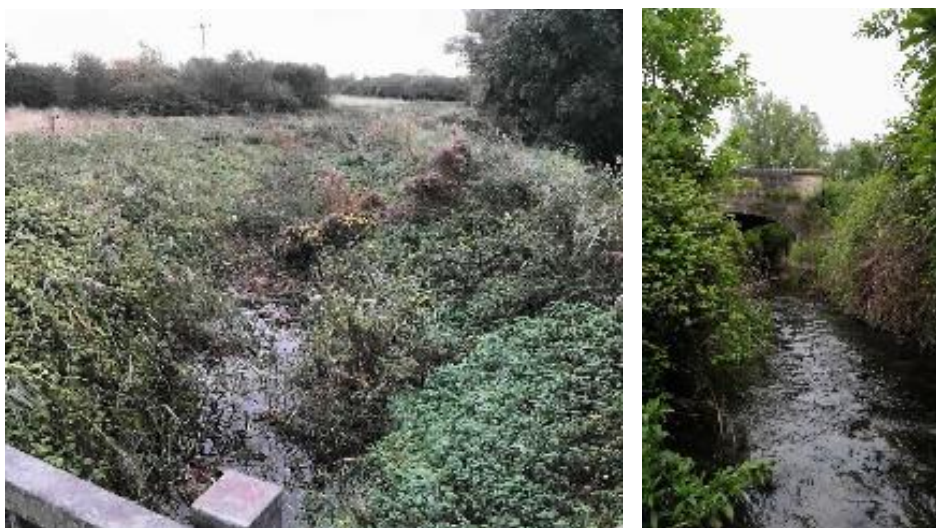
Figure 18 - Macroinvertebrate sample sites on Bottisham Lode-Quy Water (56061 (left) & 56046 (right))

4.4.5 The macroinvertebrate community at the sample sites on the Bottisham Lode-Quy Water waterbody have routinely been reported at Good status under WFD. The data were reviewed via HEV analysis in WFD cycle 1 to investigate the hydrology failure and the outcome of that investigation was that there was insufficient evidence to demonstrate a link between flow pressure and ecological impairment. The site on Quy Water (56061) is subject to very low flows during dry weather periods and was recorded dry at the Autumn 2011 sampling event.

4.4.6 Further analysis conducted in 2021 showed that after 2000, the link between WHPT ASPT O:E, WHPT NTAXA O:E and flow becomes clearer. Both indices show declines following periods of low flow in 2004/05, 2011 and 2016/17. The full effect of 2018/19 drought resulted in the watercourse being recorded dry in Autumn 2019 and Autumn 2020. WHPT NTAXA O:E fell below the Good/Moderate WFD boundary in 2018 and 2019, likely caused by the low flows. Analysis of the taxa list show numbers of flow sensitive species (*Gammarus pulex*, *Baetis* sp., Elmidae) all declining during the 2018/19 dry weather period, with *Hydropsyche* sp. not seen since 2016. The most recent dry weather period has resulted in the site being recorded dry in September 2023. The river support scheme is therefore critical in this waterbody.

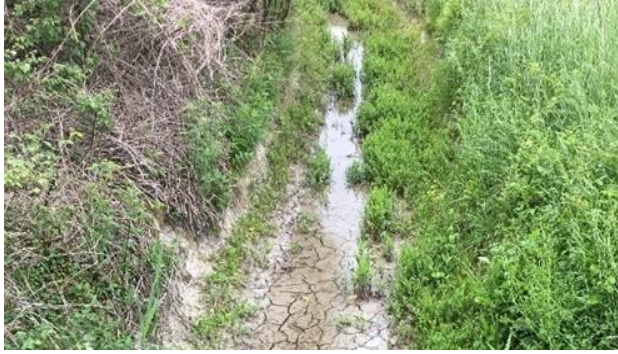
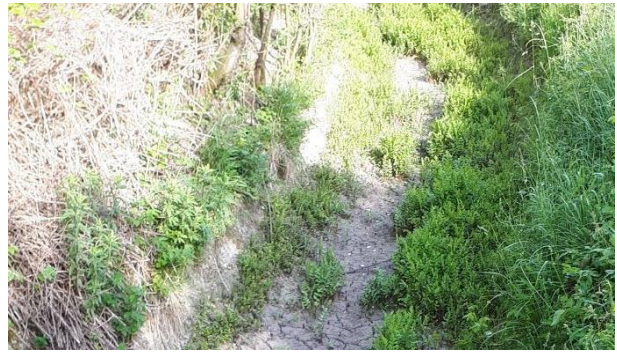
Figure 20 - Comparison of downstream section of the river with (left), and without (right) GW support during prolonged dry weather in 2019

4.4.7 The pictures below demonstrate the effect of the artificial groundwater augmentation at a location downstream. At this location, the support can be the difference between isolated pools or a completely dry bed which, ecologically can be crucial.

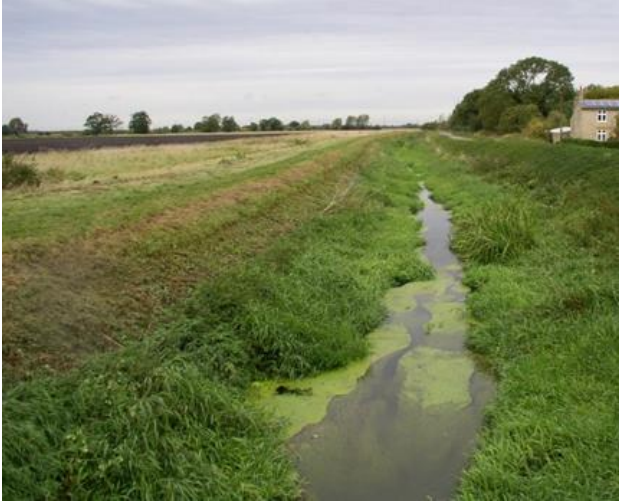
Figure 21 - Macroinvertebrate sample site on Swaffham-Bulbeck Lode (56044)

- 4.5.3 In accordance with WFD rules, a monitoring point was established in the lower reaches of the waterbody, at a location deemed to be representative of the waterbody as a whole. An investigation was undertaken in 2017 to determine whether there was an alternative location which could be assessed specifically for hydrological pressure. Due to the steep nature of the banks and the presence of a gauging station, an alternative site which represented the upper reaches, that are subject to more varied flow patterns, could not be established.

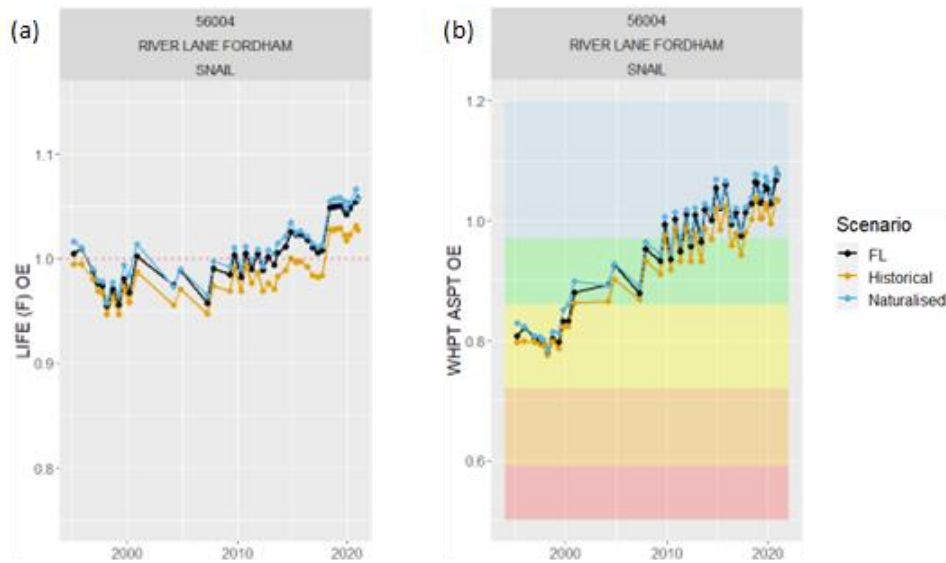
Figure 22 - Predicted LIFE (F) O/E and WHPT-ASPT O/E scores for historical, naturalised, and fully licensed scenarios for River Lane Fordham, River Snail GB105033042860 Soham Lode

- 4.6.3 Hydroecological model outputs indicate that historically there has been no discernible impact from abstraction pressure at River Lane Fordham (56004). Modelled flows at the site indicate the watercourse is discharge-rich and although historical LIFE (F) O/E and WHPT-ASPT O/E scores are lower than naturalised, this is not indicative of an abstraction pressure in this instance (see details in Appendix A; Section 3.3.6.1).
- 4.6.4 The model output indicates a negligible / no discernible abstraction impact at the site, if abstraction were to increase to Fully Licensed (FL), with similar predicted O/E metric scores displayed between the fully licensed and naturalised scenarios in recent years (2015-2020) (see Figure 22).

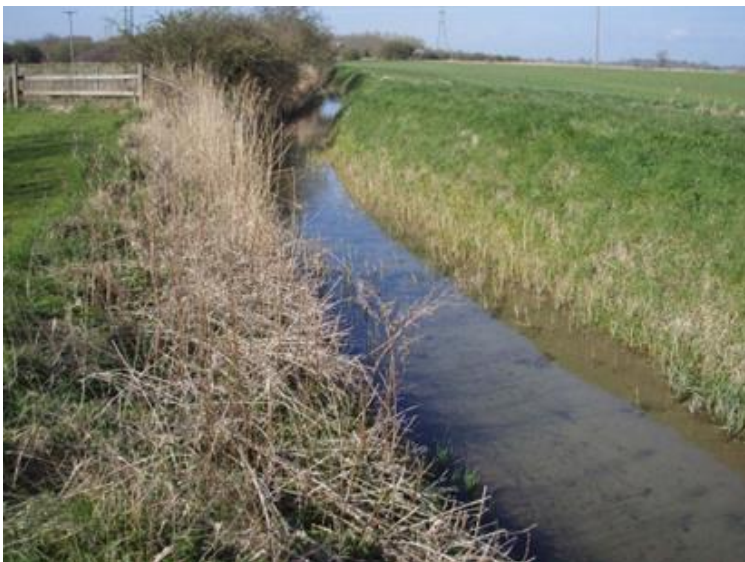
Figure 23 - Macroinvertebrate sample site on New River (56021)

- 4.7.4 In accordance with WFD rules, a monitoring point was established in the lower reaches of the waterbody, at a location deemed to be representative of the waterbody as a whole. The watercourse is modified and during the Summer has a high percentage cover of aquatic plants which could create channel narrowing which in turn may improve the flow velocity. The data were reviewed in WFD cycle 1 to investigate the hydrology failure and that investigation found insufficient evidence to demonstrate a link between flow pressure and ecological impairment.
- 4.7.5 The sample site has been found to support a regionally notable beetle *Hydraena nigrita*, which is of conservation importance. This species is assigned to flow group II in the LIFE index, indicating a species which shows a preference for moderate to fast flow velocities.

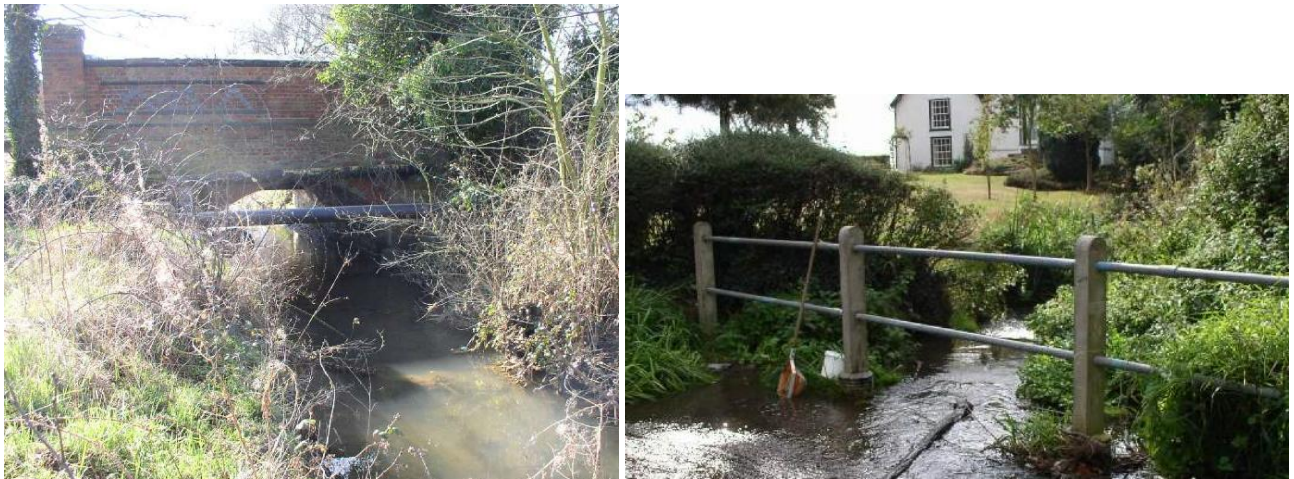
Figure 24 - Macroinvertebrate sample sites on Millbridge and Potton Brook (56191 (left) & 56196 (right))

5.1.4 The macroinvertebrate community has been assessed via HEV analysis at two sample sites in this waterbody (56191 and 56196), where water quality pressures were shown to be exerting an impact on the macroinvertebrate community. There was evidence that channel modification and flow pressures could also be impacting the macroinvertebrate community, but these impacts were partially masked by the water quality influence. Whilst the water quality has started to show signs of improvement in recent years, particularly at the 56196 sample site, it is still the primary influence on the macroinvertebrate community. It is worthy of note that during periods of low flow, the water quality impacts on the macroinvertebrate community and sediment pressures are exacerbated.

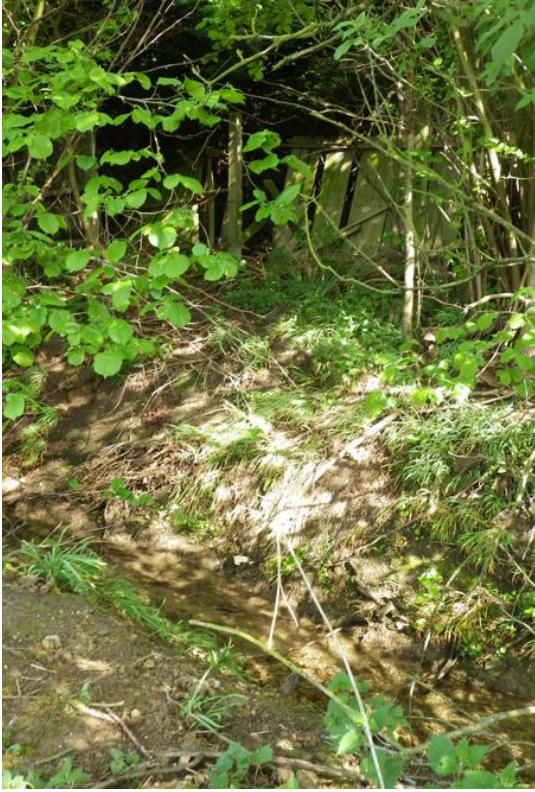
Figure 25 - Macroinvertebrate sample site on Cat Ditch (56192)

- 5.2.3 This waterbody had a historical macroinvertebrate site, which was reinstated in 2013 as part of the WFD programme. The site was visited 13 times between 2013-2019 and was recorded as dry on four occasions. Due to the frequent drying of the site, there was insufficient ecological evidence to determine whether flow pressure caused by abstraction was affecting the macroinvertebrate community.

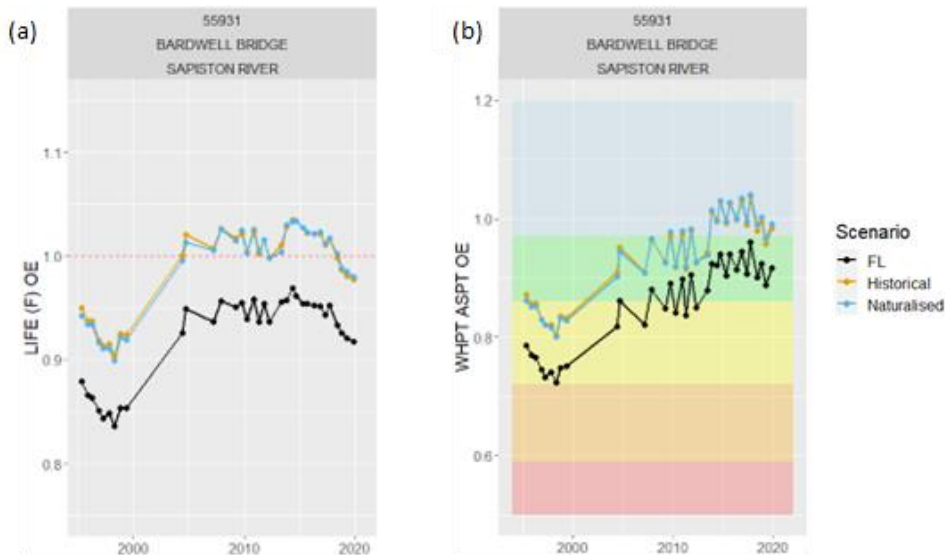
Figure 26 - Predicted LIFE (F) O/E and WHPT-ASPT O/E scores for historical, naturalised, and fully licensed scenarios for Bardwell Bridge, Sapiston River GB105033043070 Sapiston River

6.1.6 An adverse impact of abstraction pressure on the macroinvertebrate community is predicted if abstraction were to increase to Fully Licensed (FL). For recent years (2015-2020) LIFE (F) O/E scores are predicted to decline relative to historical and naturalised scenarios, and the indicative macroinvertebrate WFD status suggests a risk of deterioration from High to Good status.

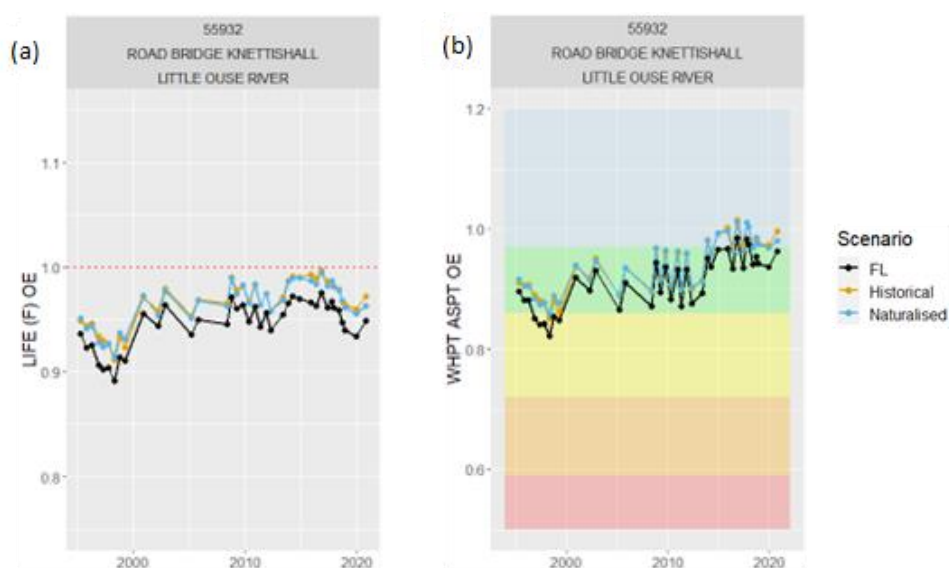
Figure 28 - Predicted LIFE (F) O/E and WHPT-ASPT O/E scores for historical, naturalised, and fully licensed scenarios for Road Bridge Knettishall, Little Ouse River GB105033043100 Little Ouse (DS Hopton Common)

- 6.3.4 Hydroecological model outputs show negligible differences between historical and naturalised LIFE (F) O/E and WHPT-ASPT O/E predicted scores indicating no discernible abstraction impact on the macroinvertebrate community at Road Bridge Knettishall (55932) (see Figure 30).
- 6.3.5 An adverse impact of abstraction pressure on the macroinvertebrate community is predicted if abstraction were to increase to Fully Licensed (FL). For recent years (2015-2020) LIFE (F) O/E scores are predicted to decline relative to historical and naturalised scenarios, and the indicative macroinvertebrate WFD status suggests a risk of deterioration from High to Good status.

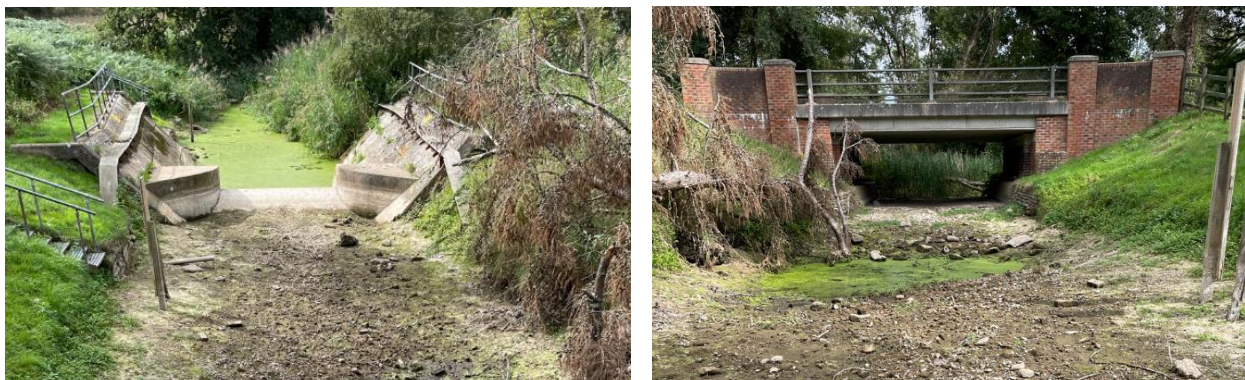
Figure 29 - Images showing dry riverbed in the month of September at Euston gauging station on the Little Ouse upstream of the Sapiston confluence during the 2022/23 drought

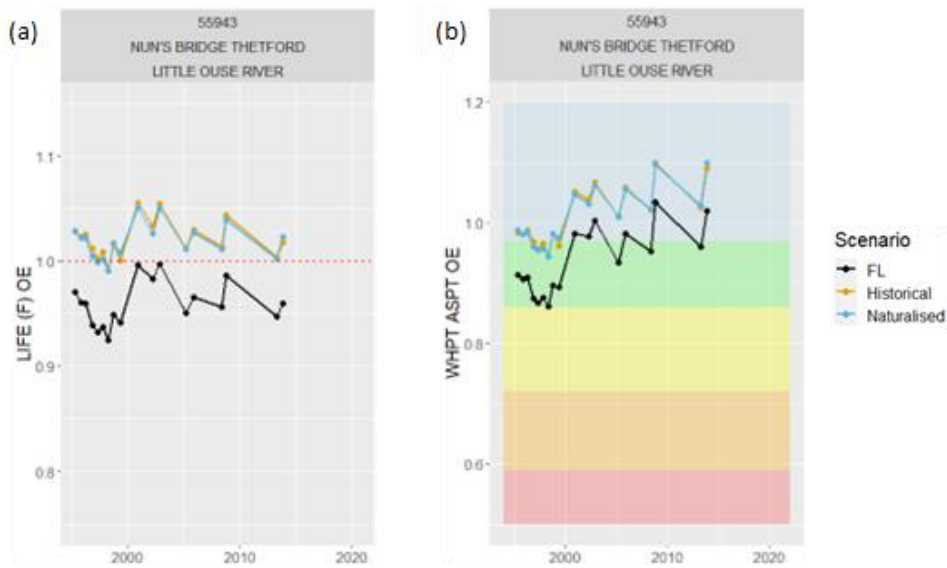
Figure 30 - Predicted LIFE (F) O/E and WHPT-ASPT O/E scores for historical, naturalised, and fully licensed scenarios for Nun's Bridge Thetford, Little Ouse River GB105033043090 Little Ouse (DS Sapiston Confl)

- 6.4.5 The model output for the fully licensed scenario shows both LIFE (F) O/E and WHPT-ASPT O/E scores to be significantly lower than historical and naturalised scenarios, indicating a significant adverse impact of increased abstraction pressure on the macroinvertebrate community. The WHPT-ASPT O/E fully licensed (FL) scores show several instances of a decline in indicative macroinvertebrate WFD class from High to Good status. Although no recent (2015-2020) data was available for model calibration when making subsequent predictions, the expectation is that relative differences in O/E scores between the fully licensed and the historical and naturalised scenarios would continue. Hence an abstraction impact on the macroinvertebrate community is expected to persist.
